STONEWALL CREEK CHANNEL & FLOODPLAIN RESTORATION

LOCATED IN SECTION 27, TOWNSHIP 15N, RANGE 9W
LATITUDE = 47.0244 NORTH; LONGITUDE = 112.7232 WEST
LEWIS AND CLARK COUNTY, MONTANA
COOPERATING PARTNERS: BIG BLACKFOOT CHAPTER TROUT UNLIMITED AND US FOREST SERVICE

VICINITY MAP AND SHEET INDEX

PLAN & PROFILE 25+00 TO 51+00

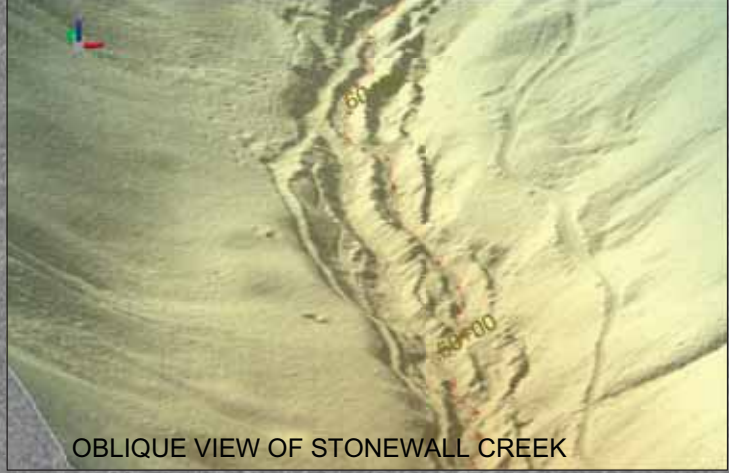
OBLIQUE VIEW OF STONEWALL CREEK

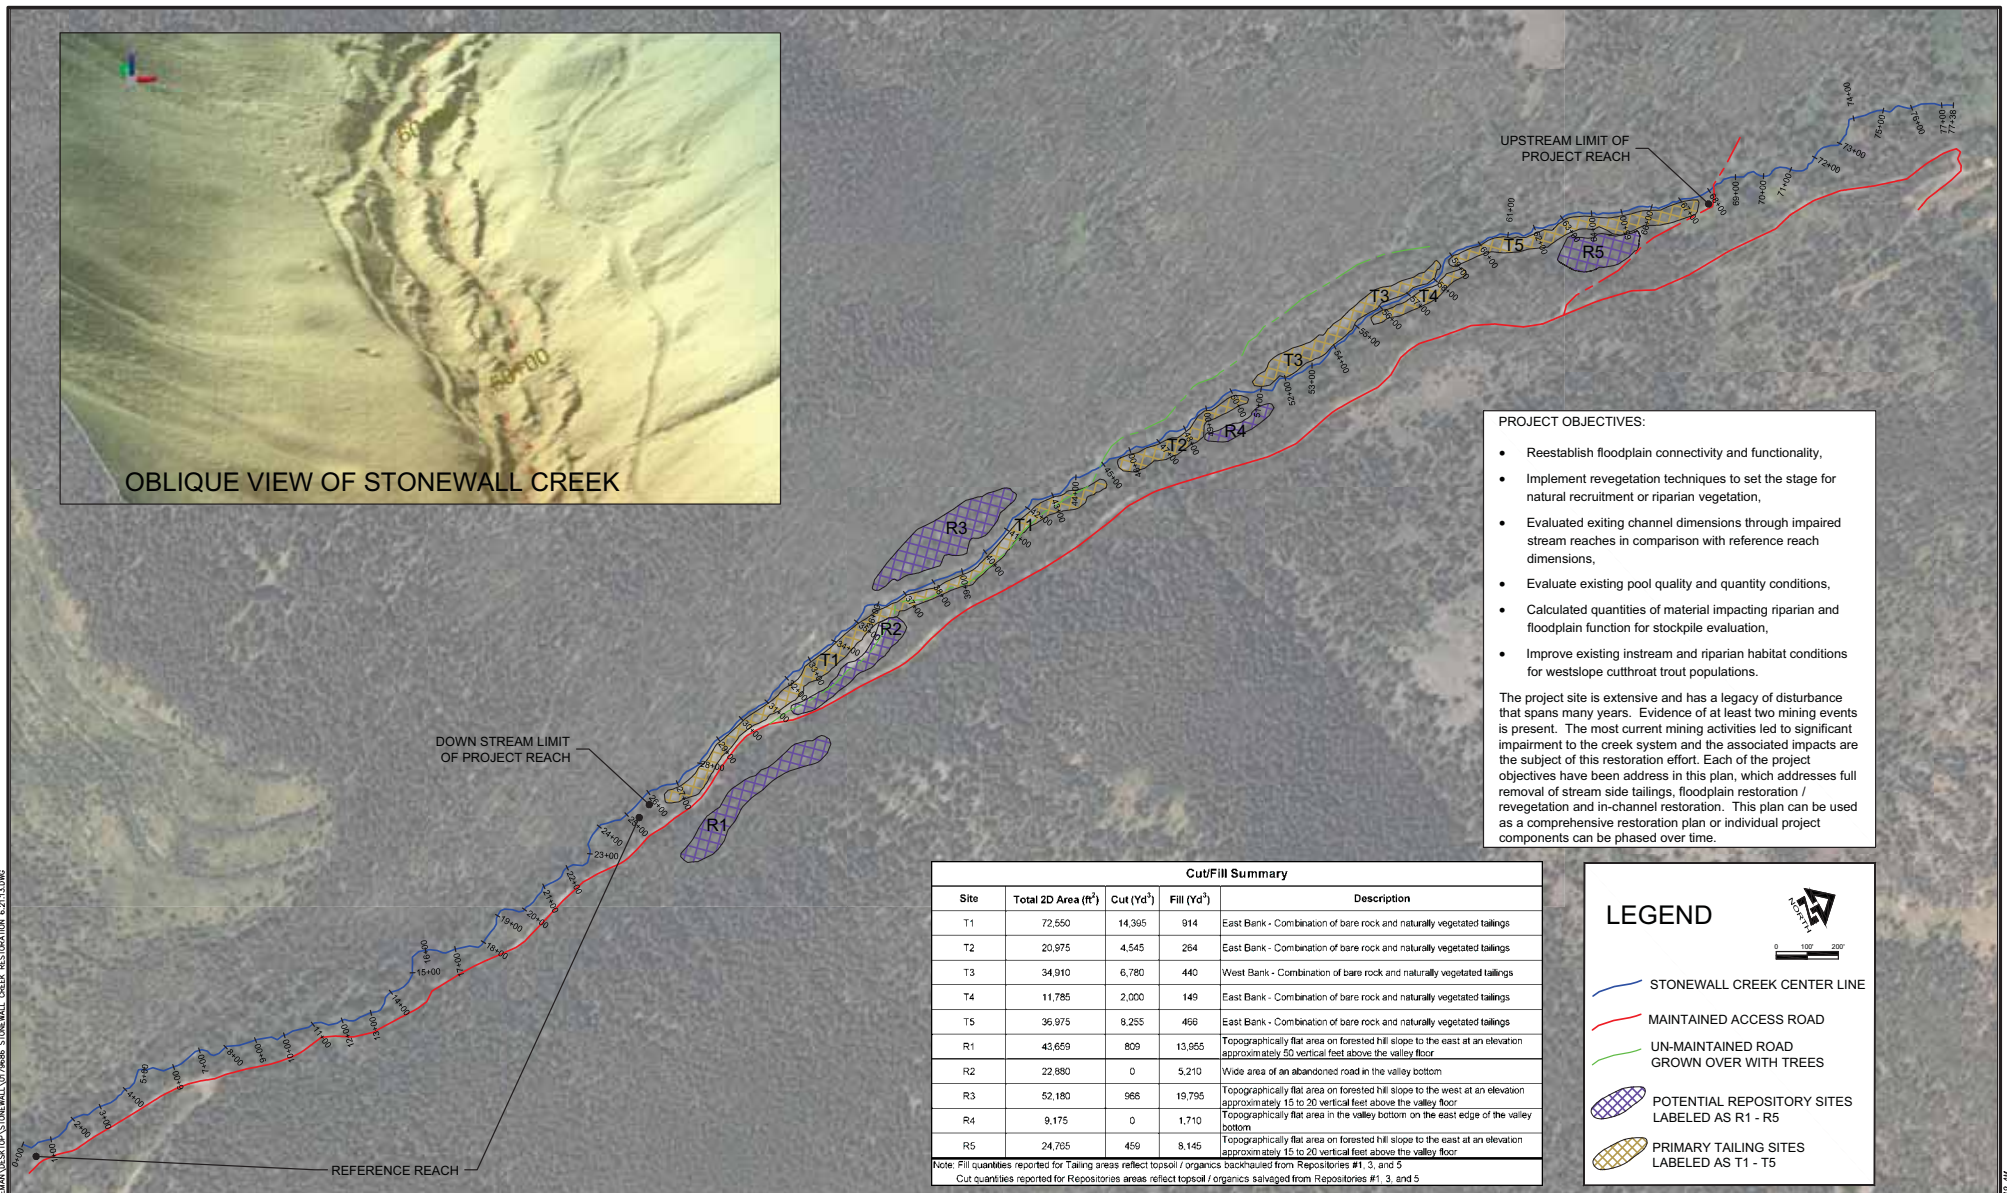
Cut/Fill Summary				
Site	Total 2D Area (ft ²)	Cut (Yd ³)	Fill (Yd ³)	Description
T1	72,550	14,365	914	East Bank - Combination of bare rock and naturally vegetated tailings
T2	20,975	4,545	264	East Bank - Combination of bare rock and naturally vegetated tailings
T3	34,910	6,780	440	West Bank - Combination of bare rock and naturally vegetated tailings
T4	11,785	2,000	149	East Bank - Combination of bare rock and naturally vegetated tailings
T5	36,975	8,255	466	East Bank - Combination of bare rock and naturally vegetated tailings
R1	43,659	809	13,855	Topographically flat area on forested hill slope to the east at an elevation approximately 15 to 20 vertical feet above the valley floor
R2	22,880	0	5,210	Wide area of an abandoned road in the valley bottom
R3	52,180	966	19,795	Topographically flat area on forested hill slope to the west at an elevation approximately 15 to 20 vertical feet above the valley floor

R4	9,175	0	1,710	Topographically flat area in the valley bottom on the east edge of the valley bottom
R5	24,765	459	9,145	Topographically flat area on forested hill slope to the east at an elevation approximately 15 to 20 vertical feet above the valley floor

Note: Fill quantities reported for Tailing areas reflect topsoil / organics backhaired from Repositories #1, 3, and 5
Cut quantities reported for Repositories areas reflect topsoil / organics salvaged from Repositories #1, 3, and 5

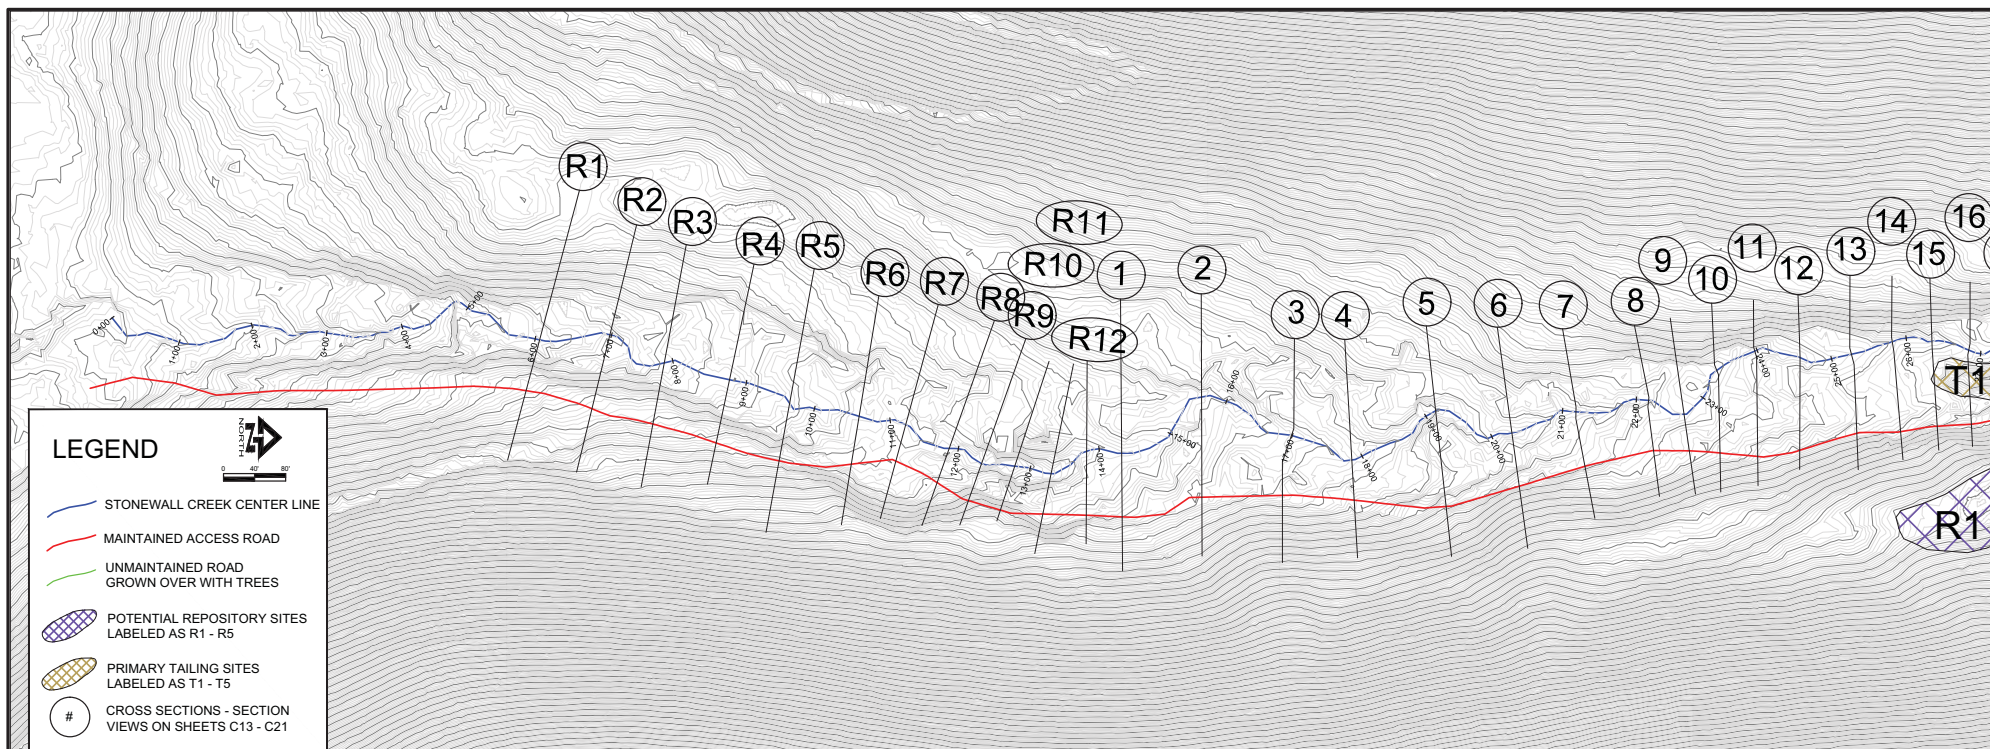
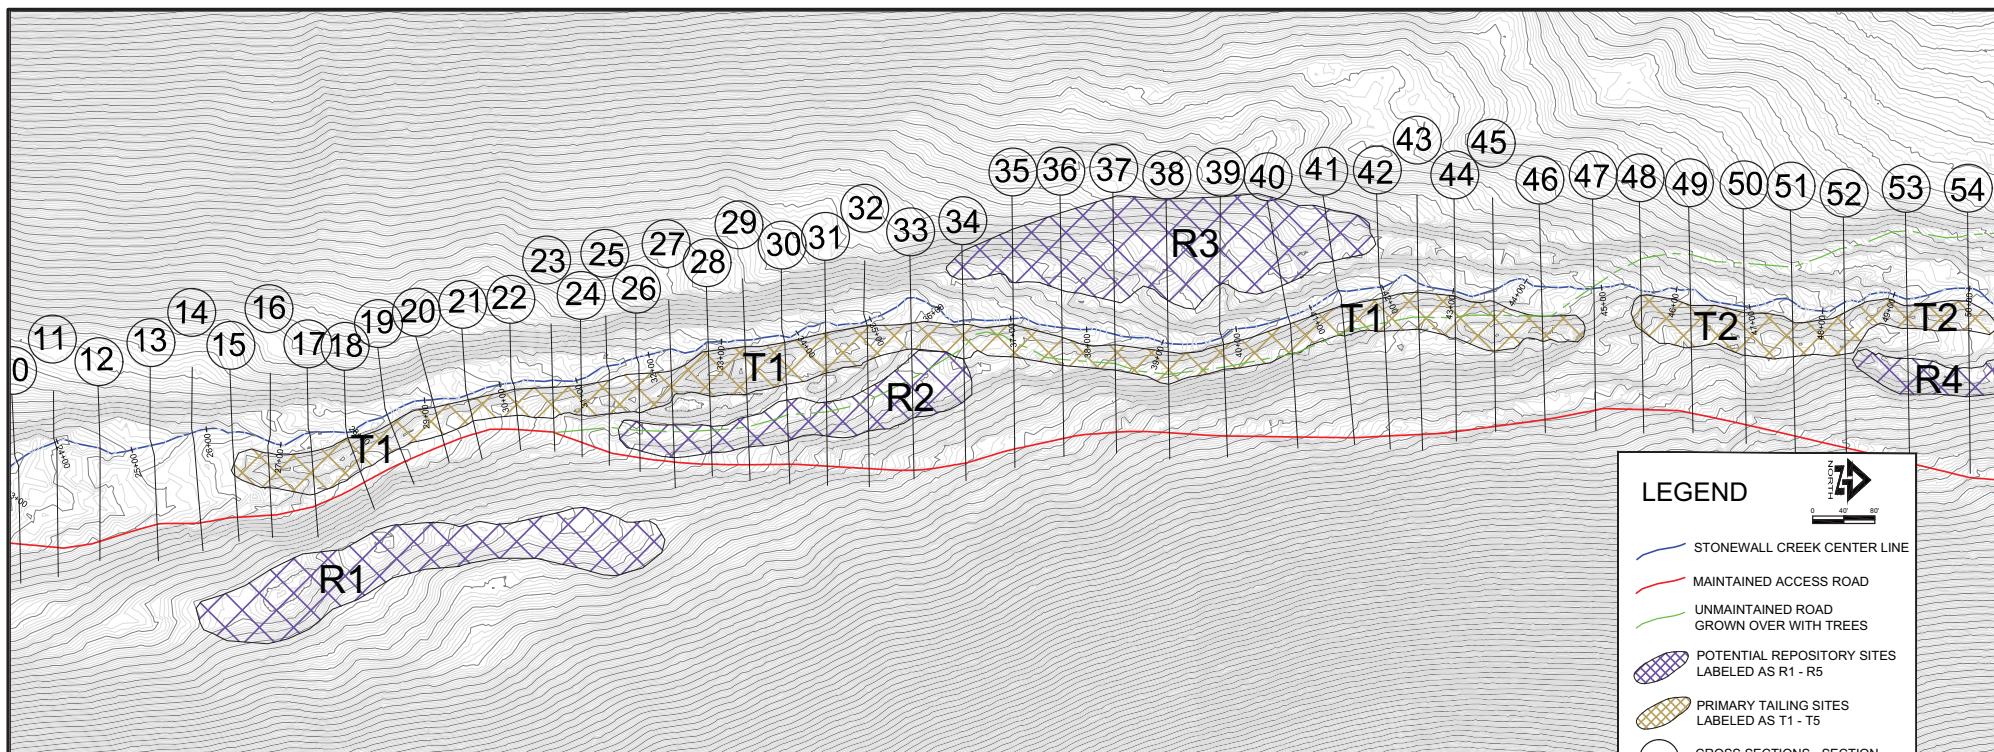
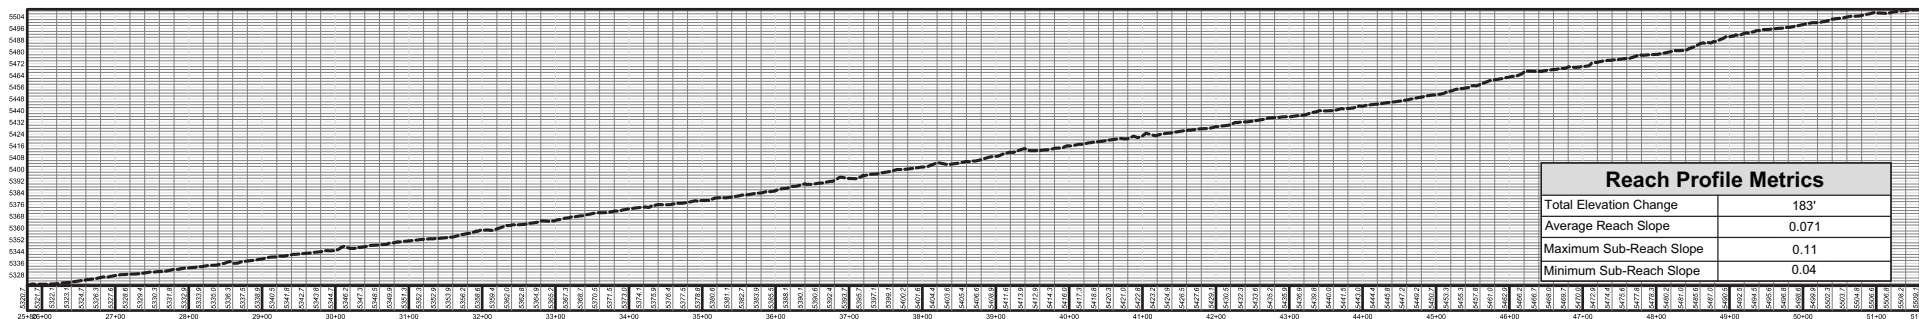
SHEET
C4

CROSS SECTIONS - SECTION VIEWS ON SHEETS C13 - C21
